# Townsville City Council Townsville Water DWQMP Annual Report

2015/ 2016 (FINANCIAL YEAR)

SPID	506
Postal Address	PO Box 1268, Townsville, QLD 4810
Principal Contact	Laura Shiels, Water Quality Officer

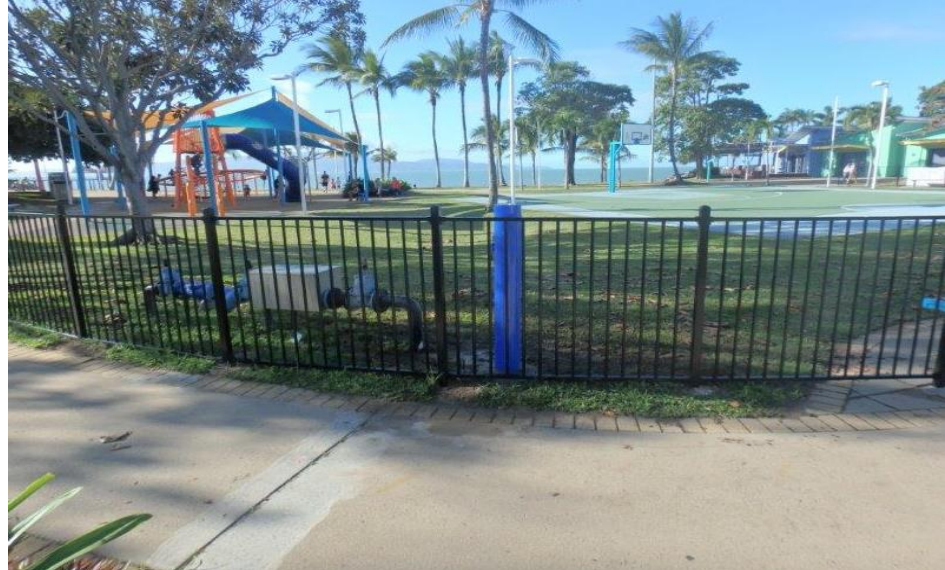
A review of sample point locations had previously been undertaken mid-2013. An issue with *E.coli* detection at a sample point in Rosslea showed that some of our sample point locations were no longer adequate. A decision was made to move sample points from houses to dedicated sample points in parks. A majority of the sample points have been relocated to appropriate parks and are housed in secure, vandal proof casings as per the blue structure in the photo below.
